#16-NA-042: Infotainment System Upgrade for Android Auto Feature - (Apr 22, 2016)

Subject: Infotainment System Upgrade for Android Auto Feature

Attention: This Bulletin applies to North America vehicles only.

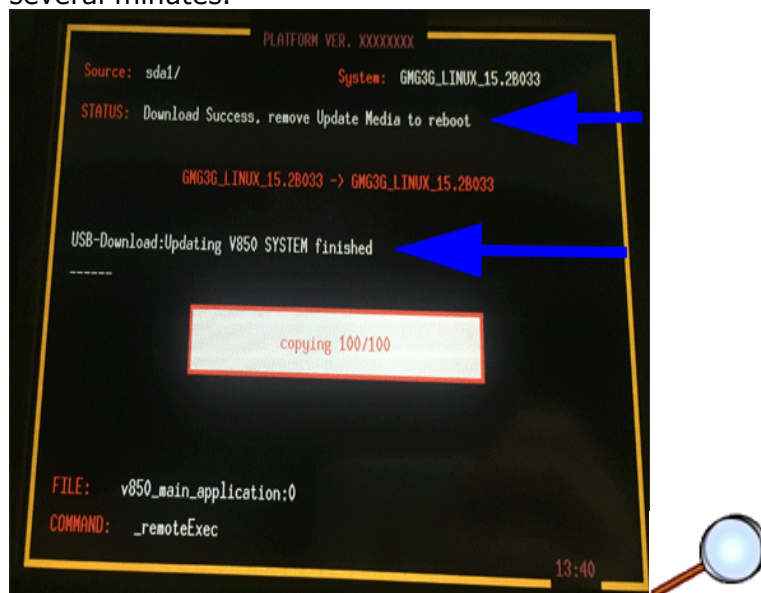
Important: Once the updating file hits 90% the screen may go blank. DO NOT REMOVE the USB at this time. The illustration above shows when the programming is complete. (See blue arrows above.)

7. Connect the USB drive to the USB port in the vehicle.
8. The infotainment system will recognize that update files are available. Follow the infotainment display on-screen instructions and select Update when prompted. Programming will take

9. Upon completion of programming, remove the USB drive. Follow the infotainment display on-screen instructions.
10. Access the Service Programming System (SPS) and follow the on-screen instructions.
11. On the SPS Supported Controllers screen, select K74 Human Machine Interface Control Module – Programming and follow the on-screen instructions.
12. At the end of programming, choose the “Clear DTCs” function on the SPS screen.
13. Ignition OFF, Retained Accessory Power (RAP) OFF, remove the key fob from range of the vehicle, and let the vehicle sit for five minutes. Retest system operation to verify the repair.

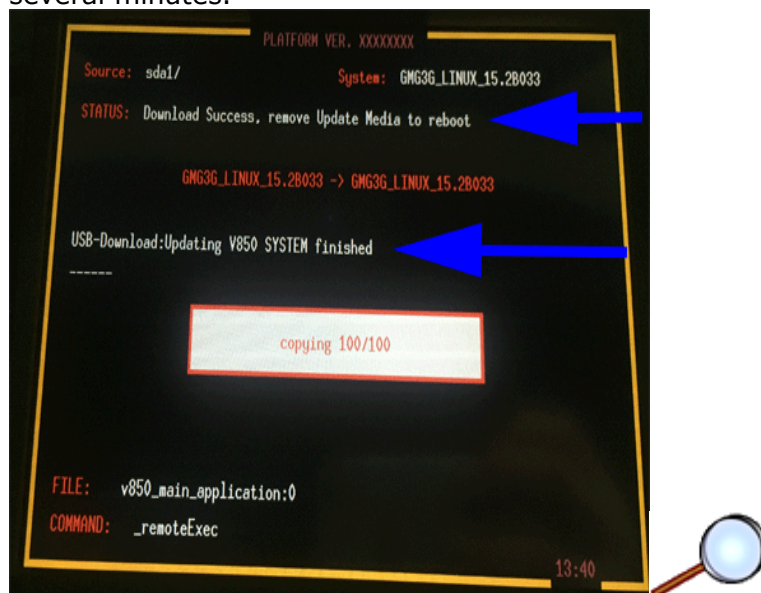
Important: Once the updating file hits 90% the screen may go blank, DO NOT REMOVE the USB at this time. The illustration above shows when the programming is complete. (See blue arrows above.)

7. Connect the USB drive to the USB port in the vehicle.
8. The infotainment system will recognize that update files are available. Follow the infotainment display on-screen instructions and select Update when prompted. Programming will take

9. Upon completion of programming, remove the USB drive. Follow the infotainment display on-screen instructions.
10. Access the Service Programming System (SPS) and follow the on-screen instructions.
11. On the SPS Supported Controllers screen, select K74 Human Machine Interface Control Module – Programming and follow the on-screen instructions.
12. At the end of programming, choose the “Clear DTCs” function on the SPS screen.
13. Ignition OFF, Retained Accessory Power (RAP) OFF, remove the key fob from range of the vehicle, and let the vehicle sit for five minutes. Retest system operation to verify the repair.
